4. TITLE (and Subtitle) Phase I Dam Inspection Report National Dam Safety Program Fairview Lake Dam (MO 10976) Boone County, Missouri		5. TYPE OF REPORT & PERIOD COVERED Final Report

FAIRVIEW LAKE DAM  
BOONE COUNTY, MISSOURI  
MISSOURI INVENTORY NO. 10976

6 PHASE I INSPECTION REPORT  
NATIONAL DAM SAFETY PROGRAM

Name of Dam: Fairview Lake Dam  
State Located: Missouri  
County Located: Boone County  
Stream: Tributary to County House Branch  
Date of Inspection: 13 April 1978

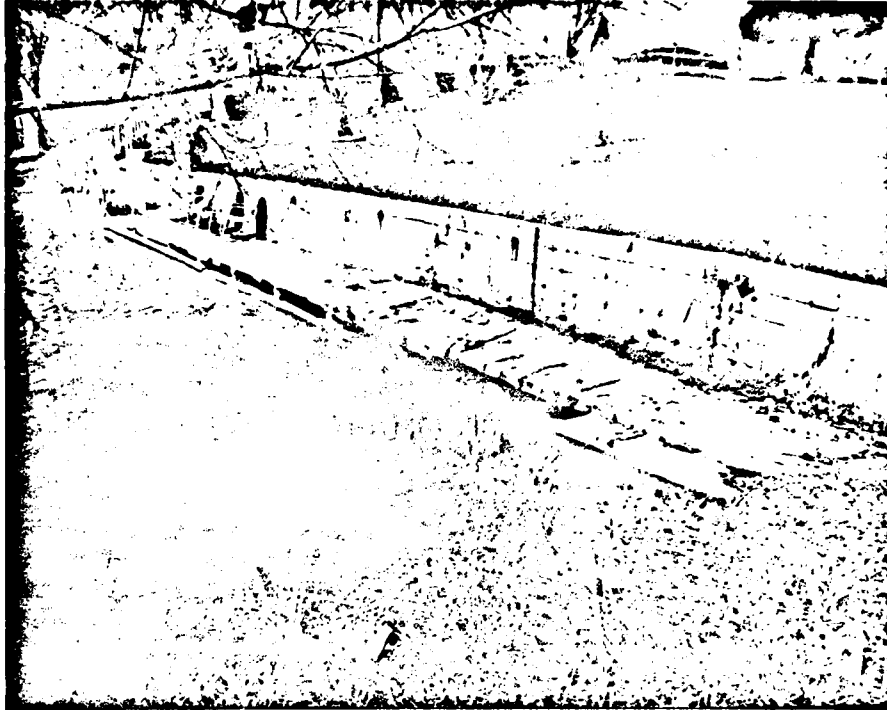
PHOTO 1

Some deterioration of concrete was noticed at the lower end of the horizontal lip of the curb opening drop inlet spillway (see Photo 1). Two pipes were visible on the downstream slope of the dam. One 30-inch CMP was near the left abutment to release the water from the upstream spillway. One 14 inch CMP was near the center of the dam several feet above the toe to drain the storm water from pavement on top of the embankment of the dam. A significant amount of erosion and undermining at the exit ends of both pipes were noticed (see photos 2 and 7). The collapse of the slab downstream of the 30-inch pipe, as shown in Photo 2, was probably attributed to flow overtopping the sides of slab in sufficient quantity and rate to cause erosion and undermining.

Curb opening drop inlet spillway, Fairview Lake Dam

(3) Keep the culverts and spillway clean.

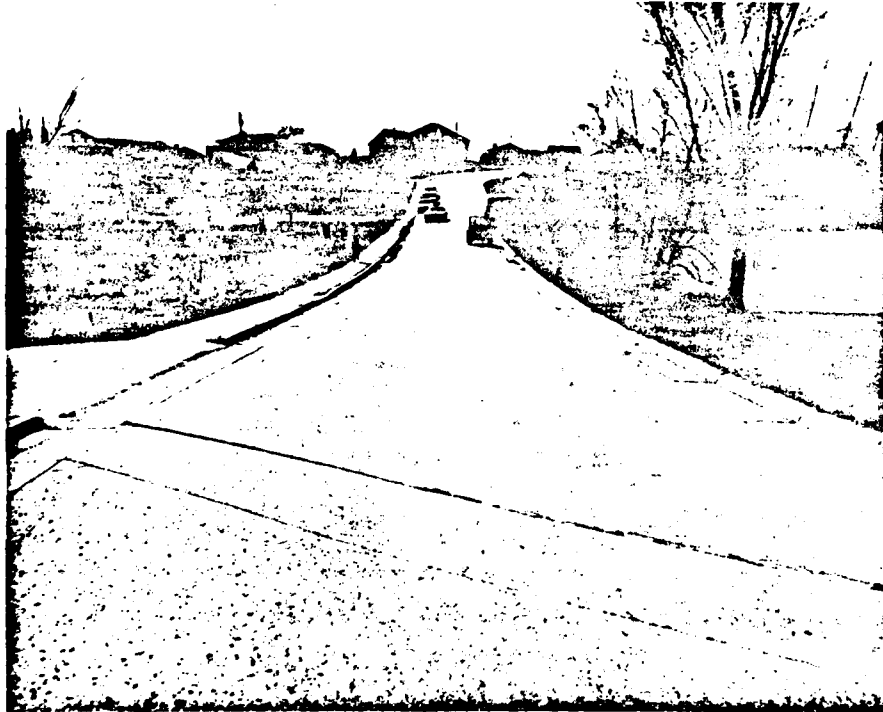
PHOTO 4

Fairview Lake Dam

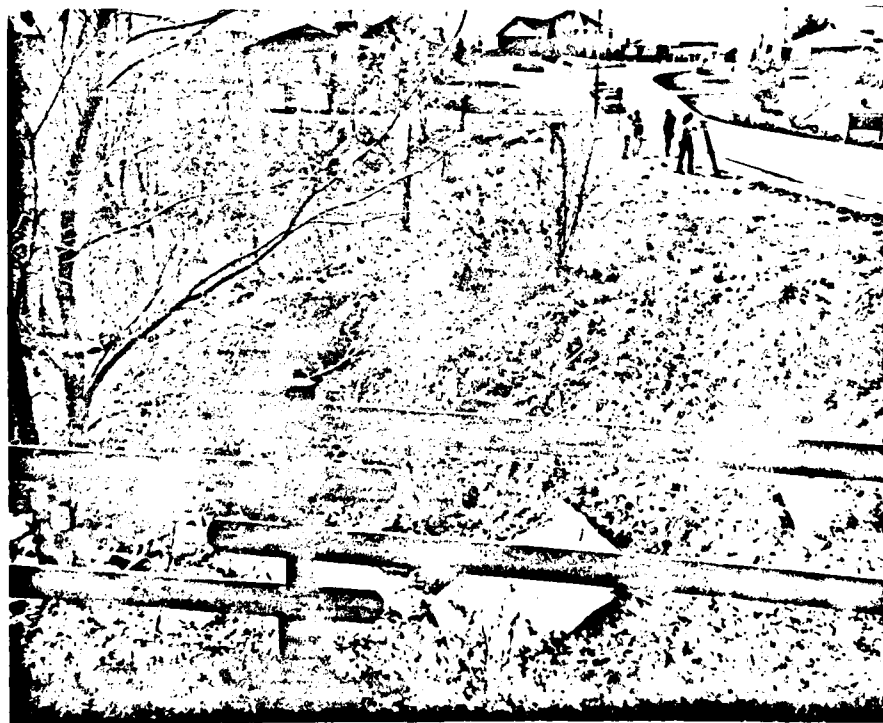
PHOTO 6

b. Heavy vegetation and trees growing on the downstream slope of the dam.

Downstream of Fairview Lake Dam (2 of 2)

(1) Remove trees and heavy vegetation from the slopes of the dam.

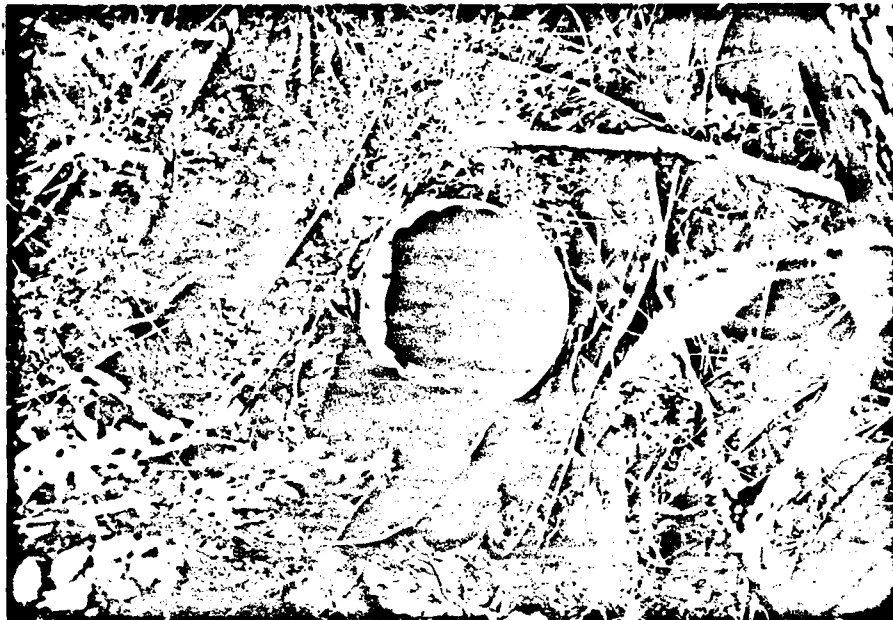
PHOTO 7  
14" CMP (Downstream) Fairview Lake Dam

(2) Repair erosion and undermining and provide erosion protection and/or energy dissipators at the exit end of the two pipes on the downstream slope of Fairview Lake Dam.
